<b>GROUP</b> <b>Fuel System</b>	<b>MODEL</b> 2011-2013MY Optima w/2.0L & 2.4L GDI (QF/TF) 2011-2013MY Sportage w/2.0L GDI (SL) 2012-2014MY Sorento w/2.4 GDI (XM) 2014MY Sorento w/3.3L GDI (XM) 2014MY Cadenza w/3.3L GDI (VG)
	<b>NUMBER</b> <b>026</b>	<b>DATE</b> <b>September 2013</b>

## TECHNICAL SERVICE BULLETIN

**SUBJECT:** MIL ON WITH DTC P0087 - DIAGNOSIS AND REPAIR

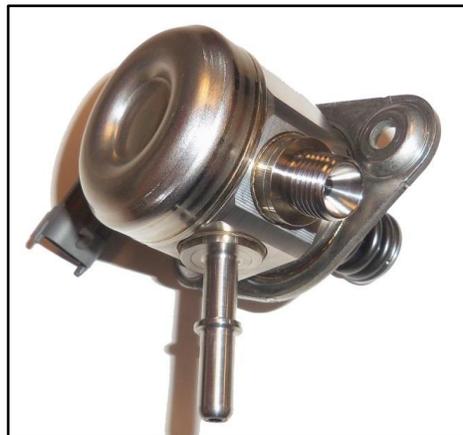
High Pressure Fuel Pump

DTC P0087 - Fuel Rail Pressure (FRP) Too Low

This bulletin provides information related to some Optima (TF/QF), Sportage (SL), Sorento (XM) and Cadenza (VG) vehicles, which may experience a malfunction indicator lamp (MIL) illuminated with the ECM (Electronic Control Module) system-related DTC P0087. To correct this concern, follow the procedure outlined in this bulletin and, if necessary, replace the high pressure fuel pump, fuel delivery pipe and mounting bolts.

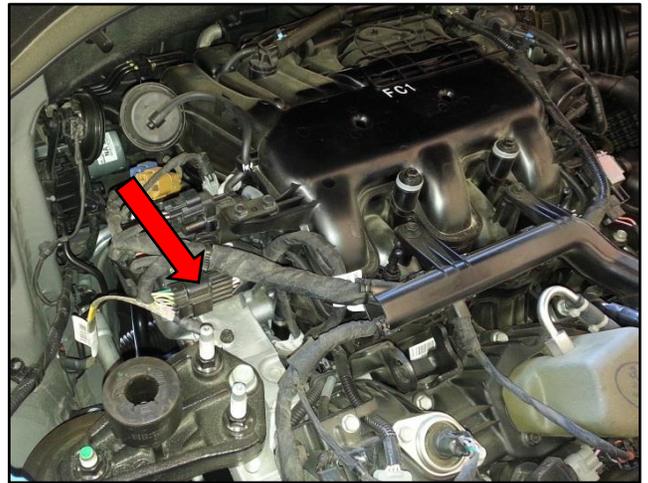
1. Check for other DTCs that would point to the low pressure fuel pump or fuel pressure sensor. Correct and repair as required.
2. Inspect the electrical connections at both the pump and the fuel pressure sensor.
  - On 3.3L GDI equipped vehicles, check connector CC22B.

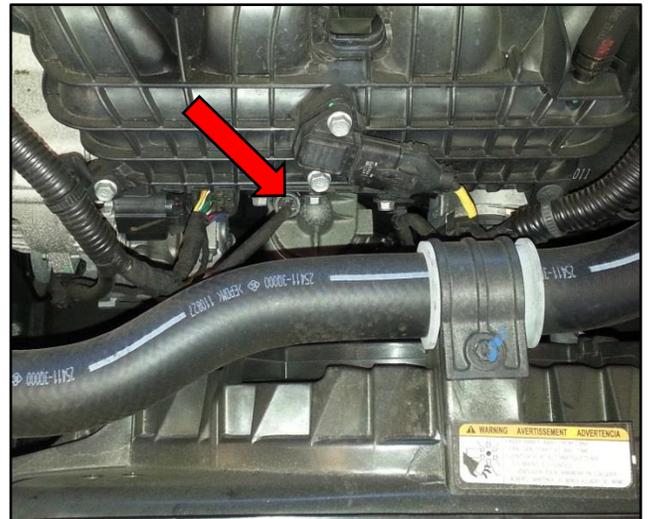
- On 2.0L and 2.4L GDI equipped vehicles, check connector CHGINJ (12-BLK).
